Tidal Wetland Restoration Handbook
Wetland Restoration Site Locations

Tidal Wetland Restoration Handbook

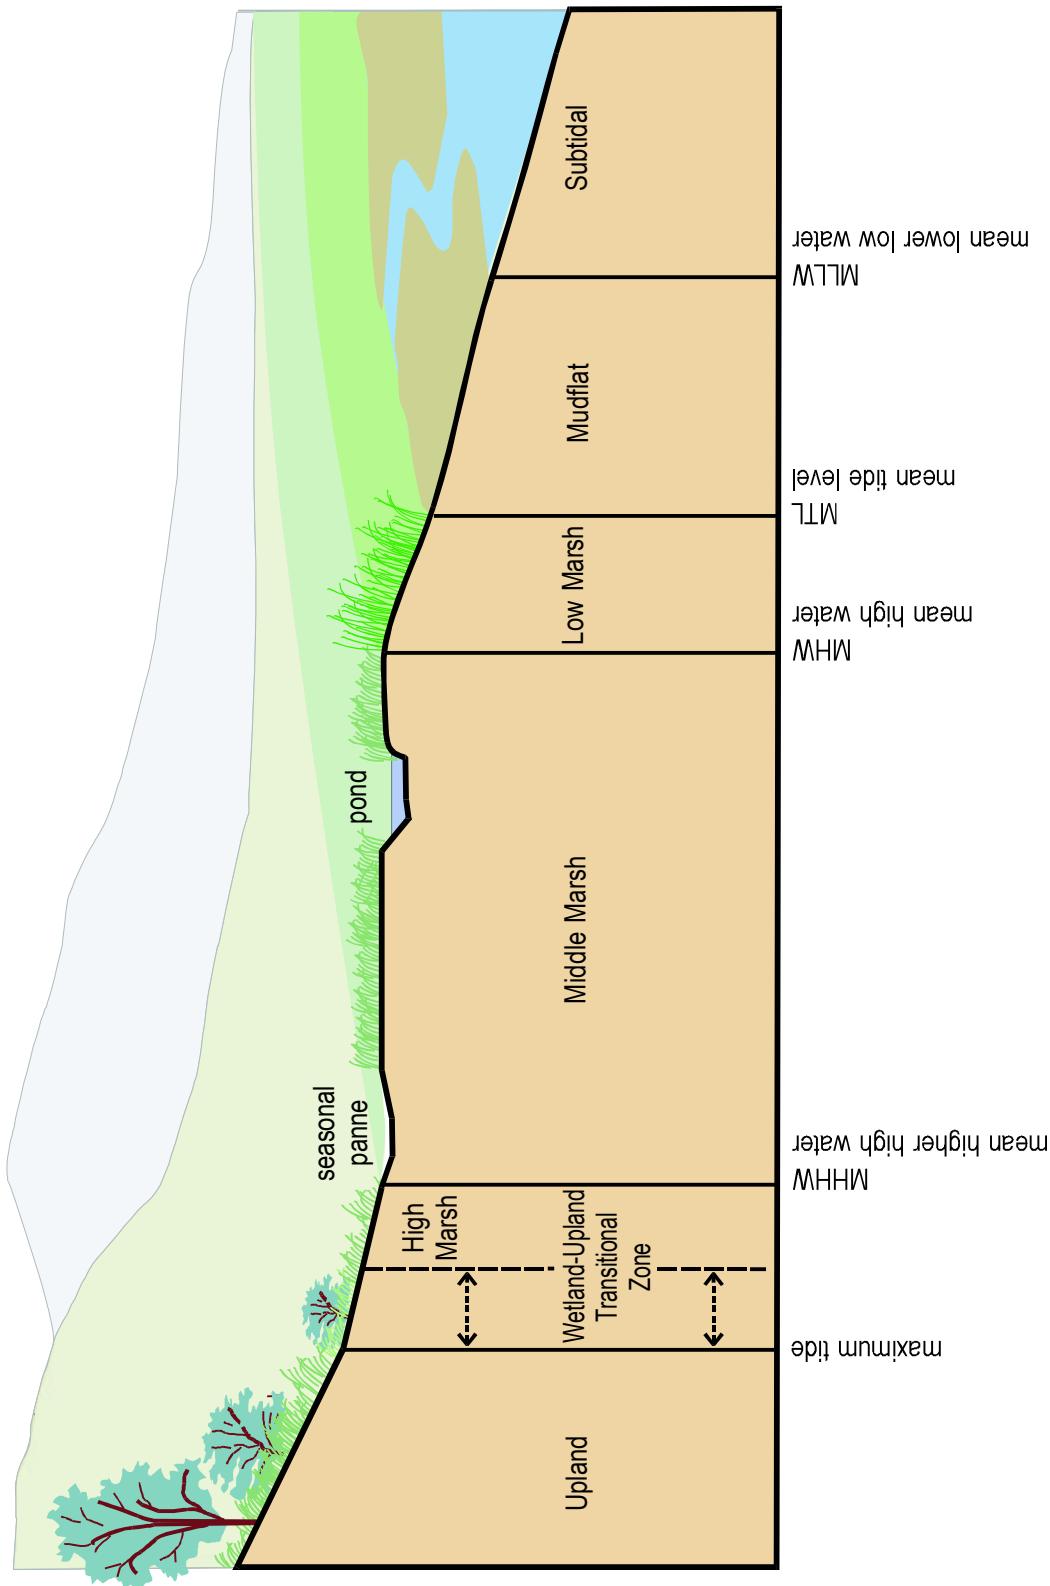
figure 2

Note:
The landward boundary of the high marsh shifts from year to year within the wetland-upland transition zone.

Vertical Profile of Tidal Marsh

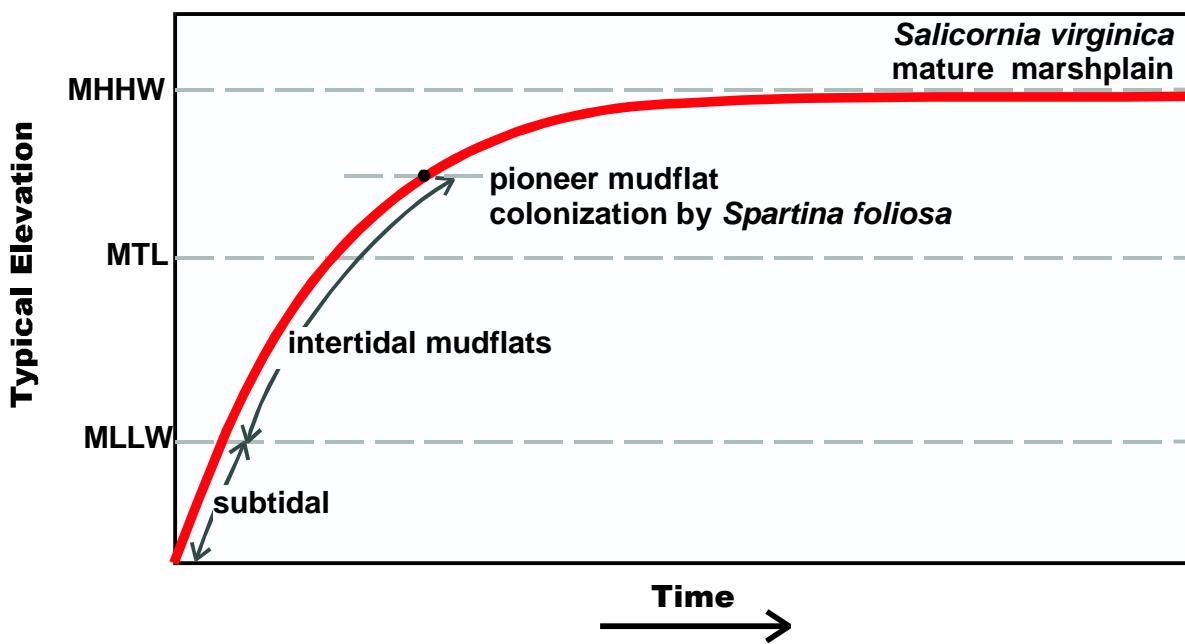
figure 7

Evolutionary Trajectory of Restoring Tidal Marsh

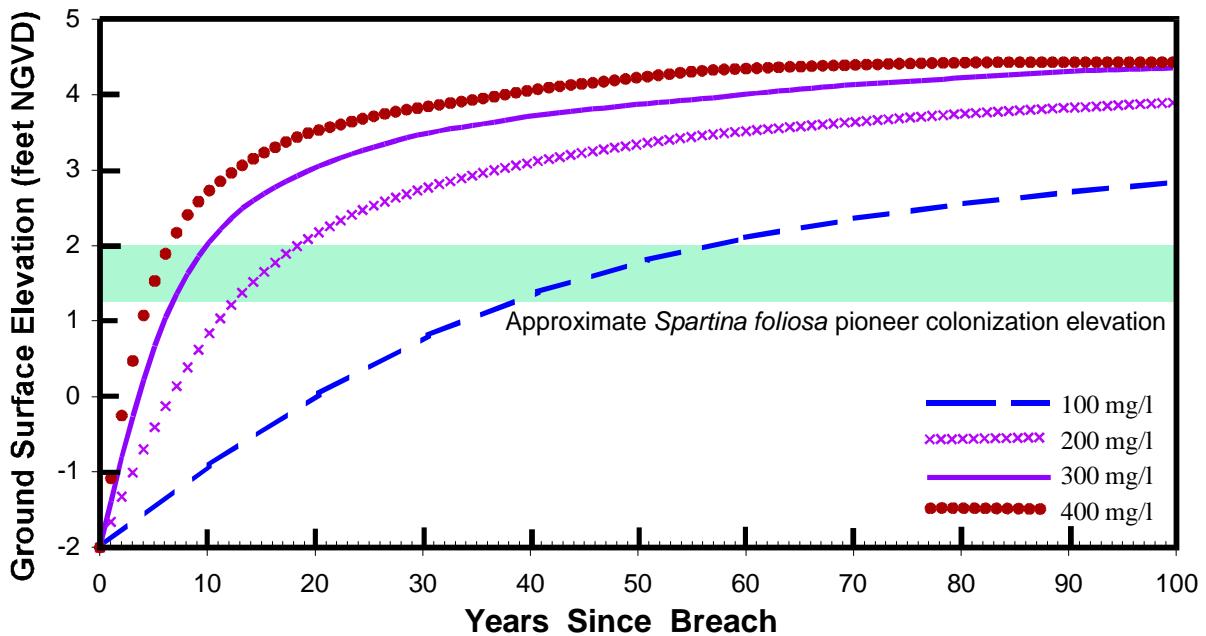
figure 8

Tidal Wetland Restoration Handbook
Effect of Suspended Sediment Concentration on Marshplain Evolution

Shaded bar identifies the approximate *Spartina foliosa* colonization elevation. Prediction is based on tides at the Presidio, no sea level rise, and 550 kg/m³ dry density of inorganics, typical for San Francisco Bay.

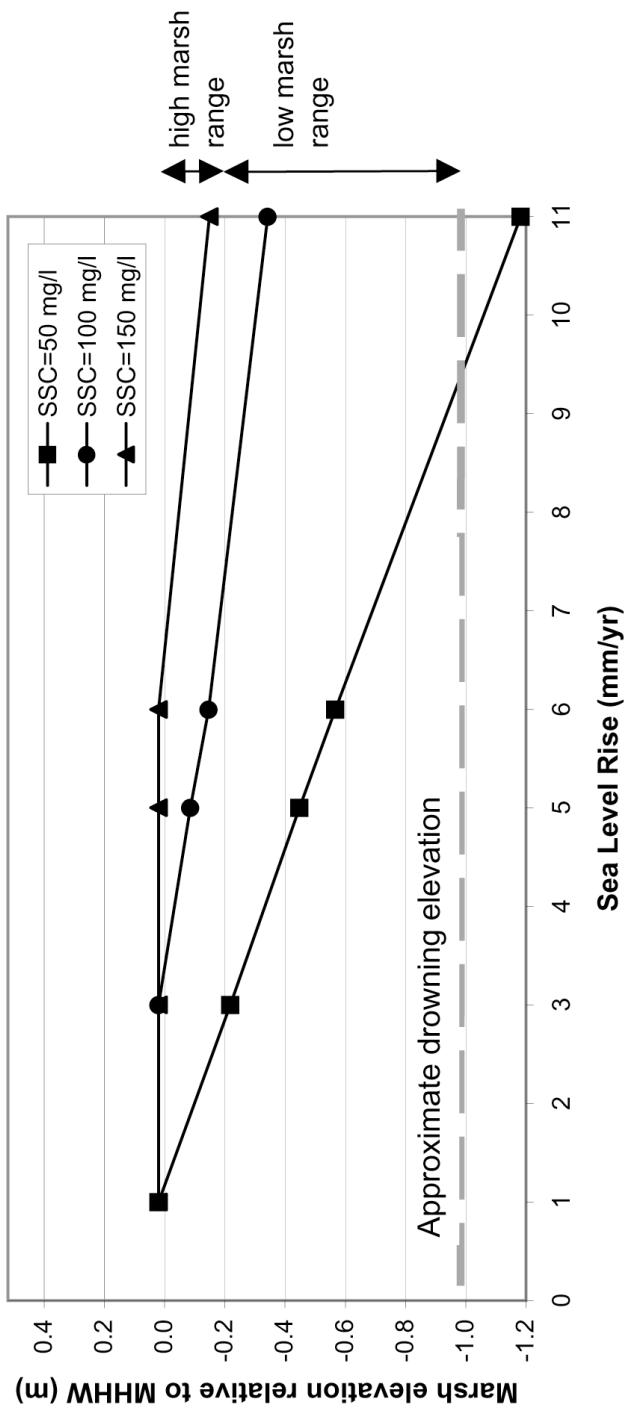
figure 9

San Pablo Bay equilibrium marsh elevation as a function of sea level rise and suspended sediment concentration (SSC). Note that marsh elevations for the low suspended sediment scenario may be overestimated because the marsh did not reach an equilibrium elevation within the 500 years modeled.

Effect of Relative Sea Level Rise on Marshplain Evolution

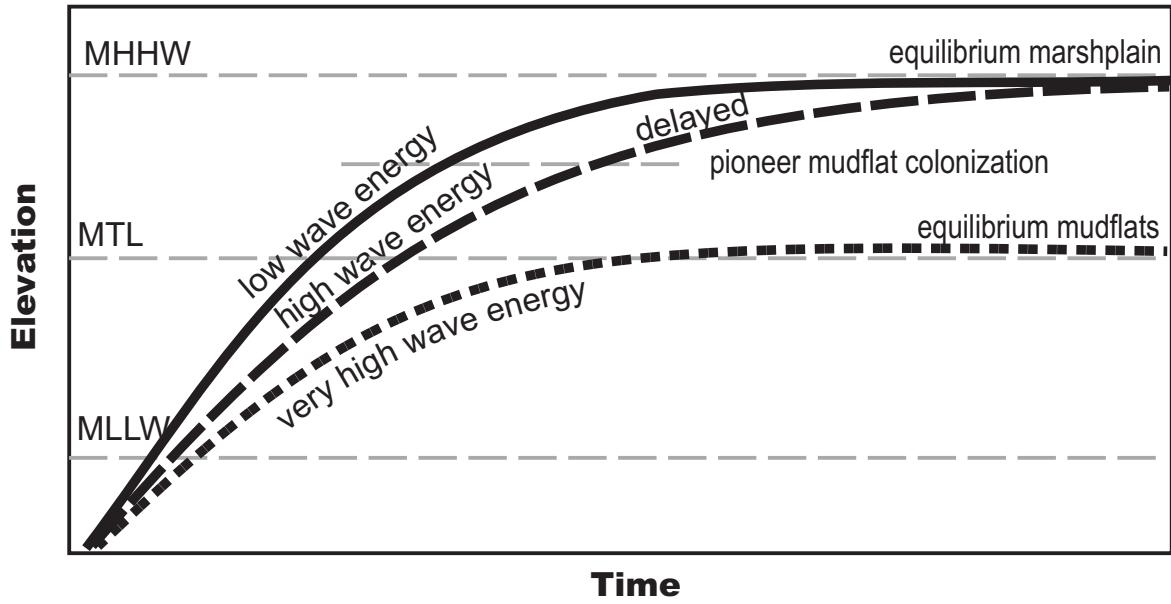
figure 10

Conceptual Effect of Wind Waves on Tidal Marsh Evolution

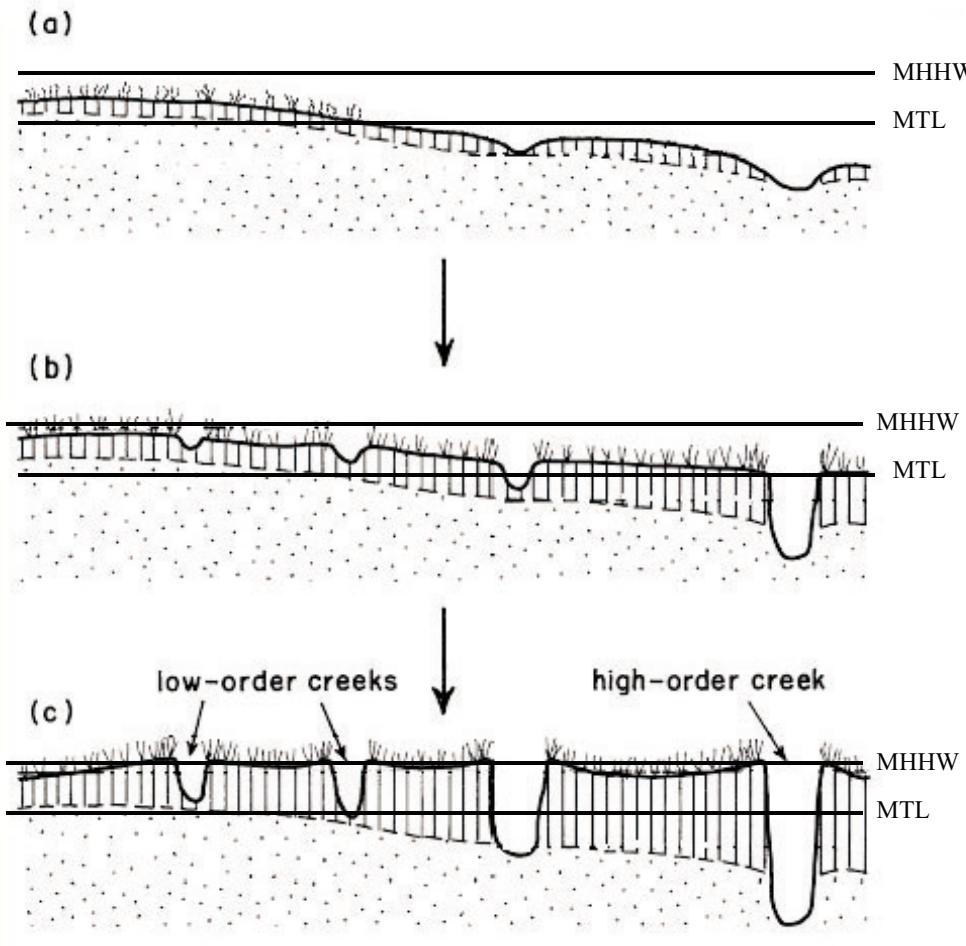
figure 11

Schematic of youthful marsh development.

- Young marsh low in the tidal frame with precursor mudflat and incipient channels.
- Developing marsh showing more extensive vegetation colonization and channel formation.
- Mature marsh with fully vegetated marsh plain and channel drainage system.

Speckled fill is mud;
hatched fill is marsh soil.

Tidal Marshplain Evolution with Time

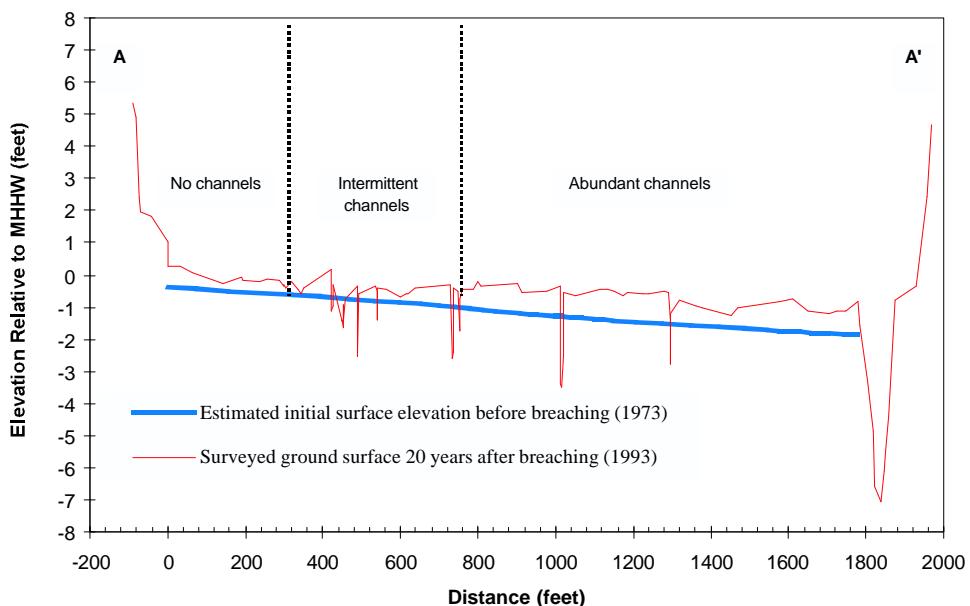
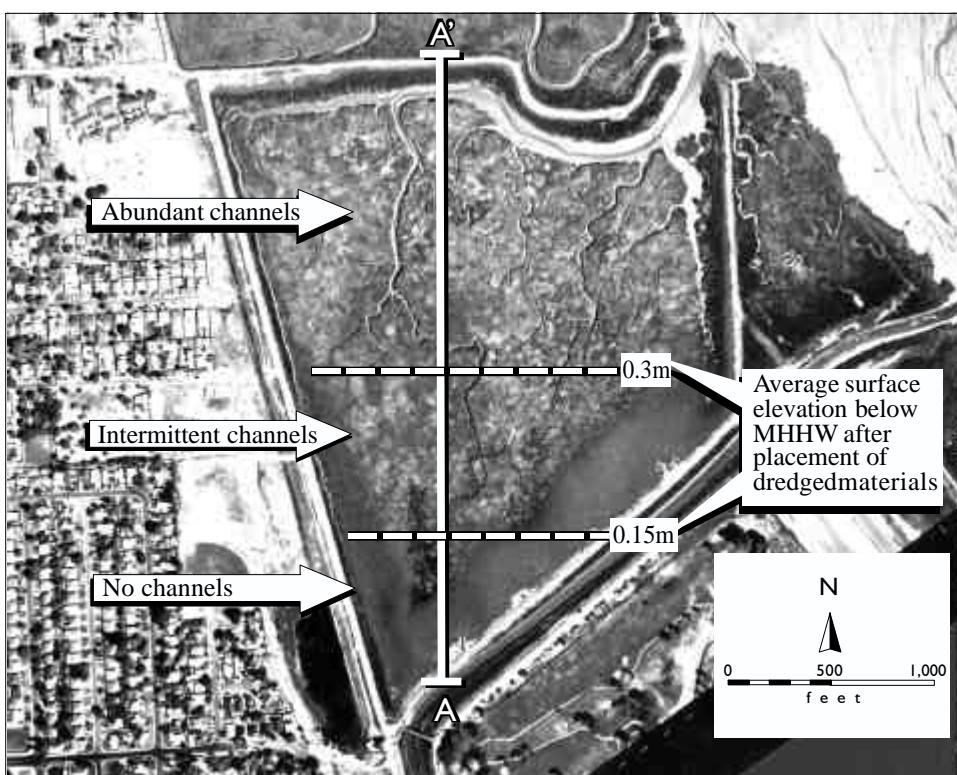
figure 14

Elevation profile at top shows estimated initial ground elevations before breaching in 1973. Dotted lines in the cross-section and photograph indicate zones of channel abundance

Pre Breach Ground Surface Elevation and Slough Channel Abundance at Faber Tract

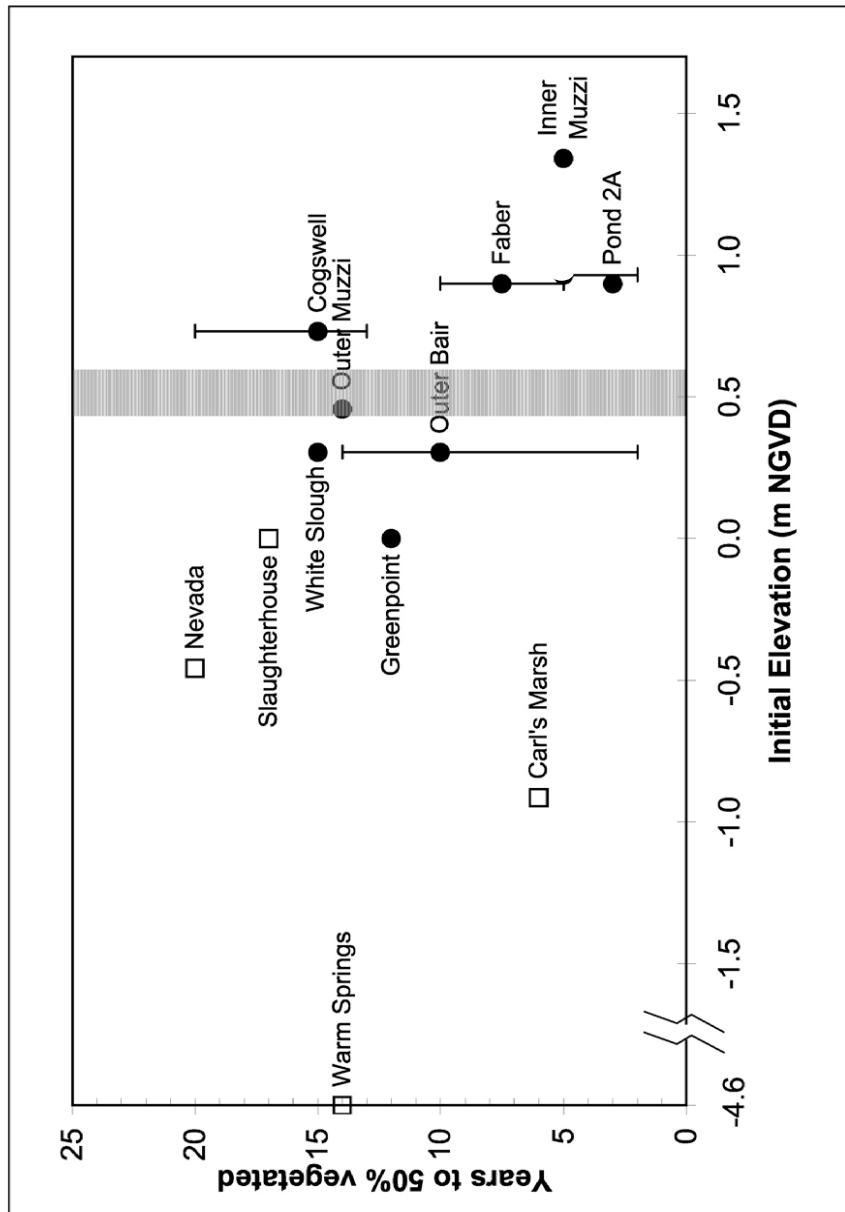
figure 16

Number of years for marshplain vegetation to establish versus initial elevation. Shaded bar identifies the approximate Spartina colonization elevation. Error bars represent the range of uncertainty based on the data available to bracket the time frame. Damped tidal sites excluded.

Colonization Elevation

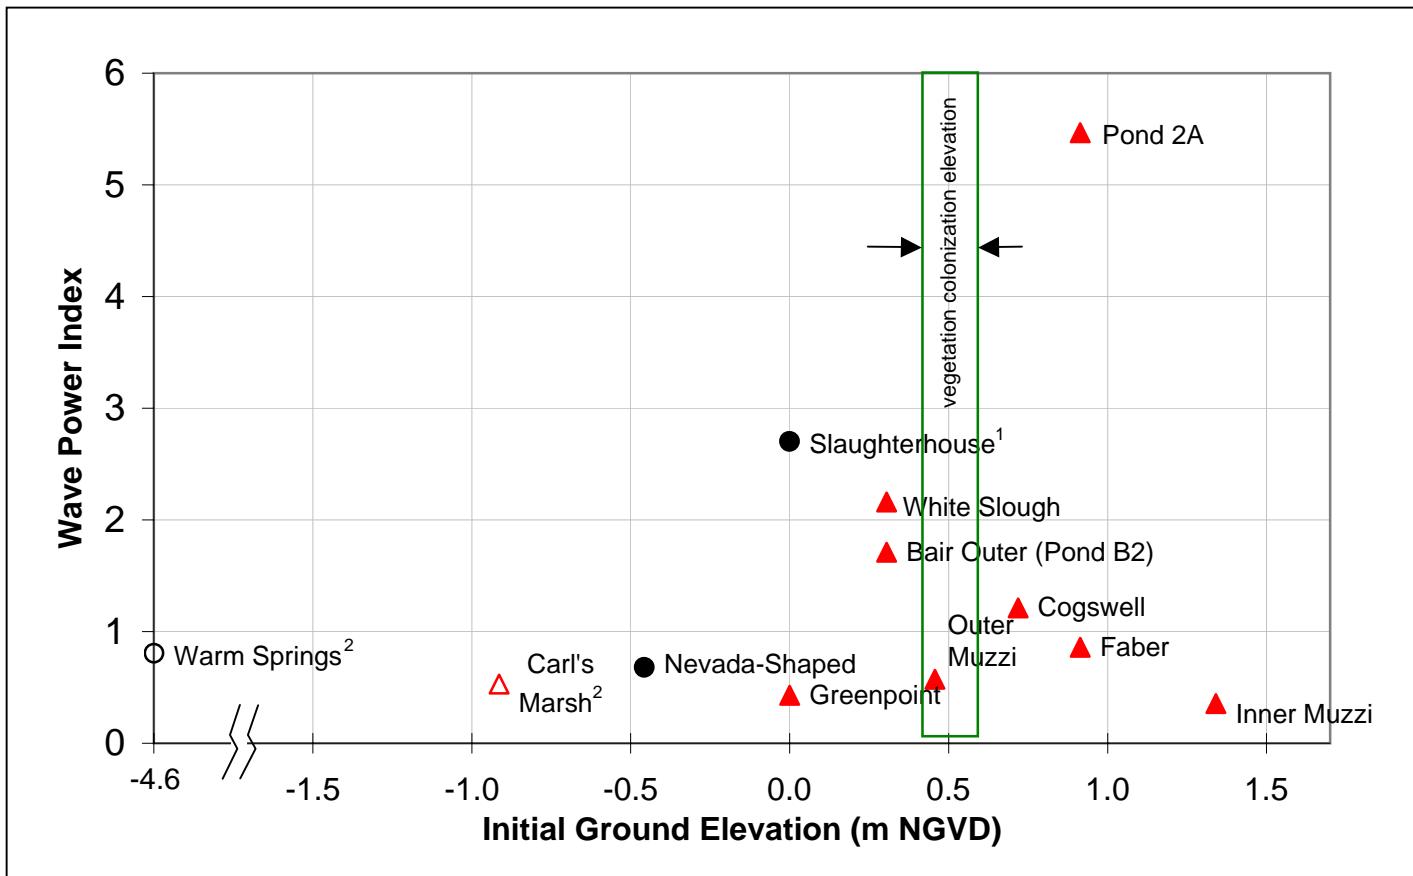
figure 35
Tidal Wetlands Restoration Handbook

▲ Vegetated 15 years after breaching
 ● Unvegetated 15 years after breaching

Initial Ground Elevation, Wave Power Index, & Vegetation Status of Study Sites

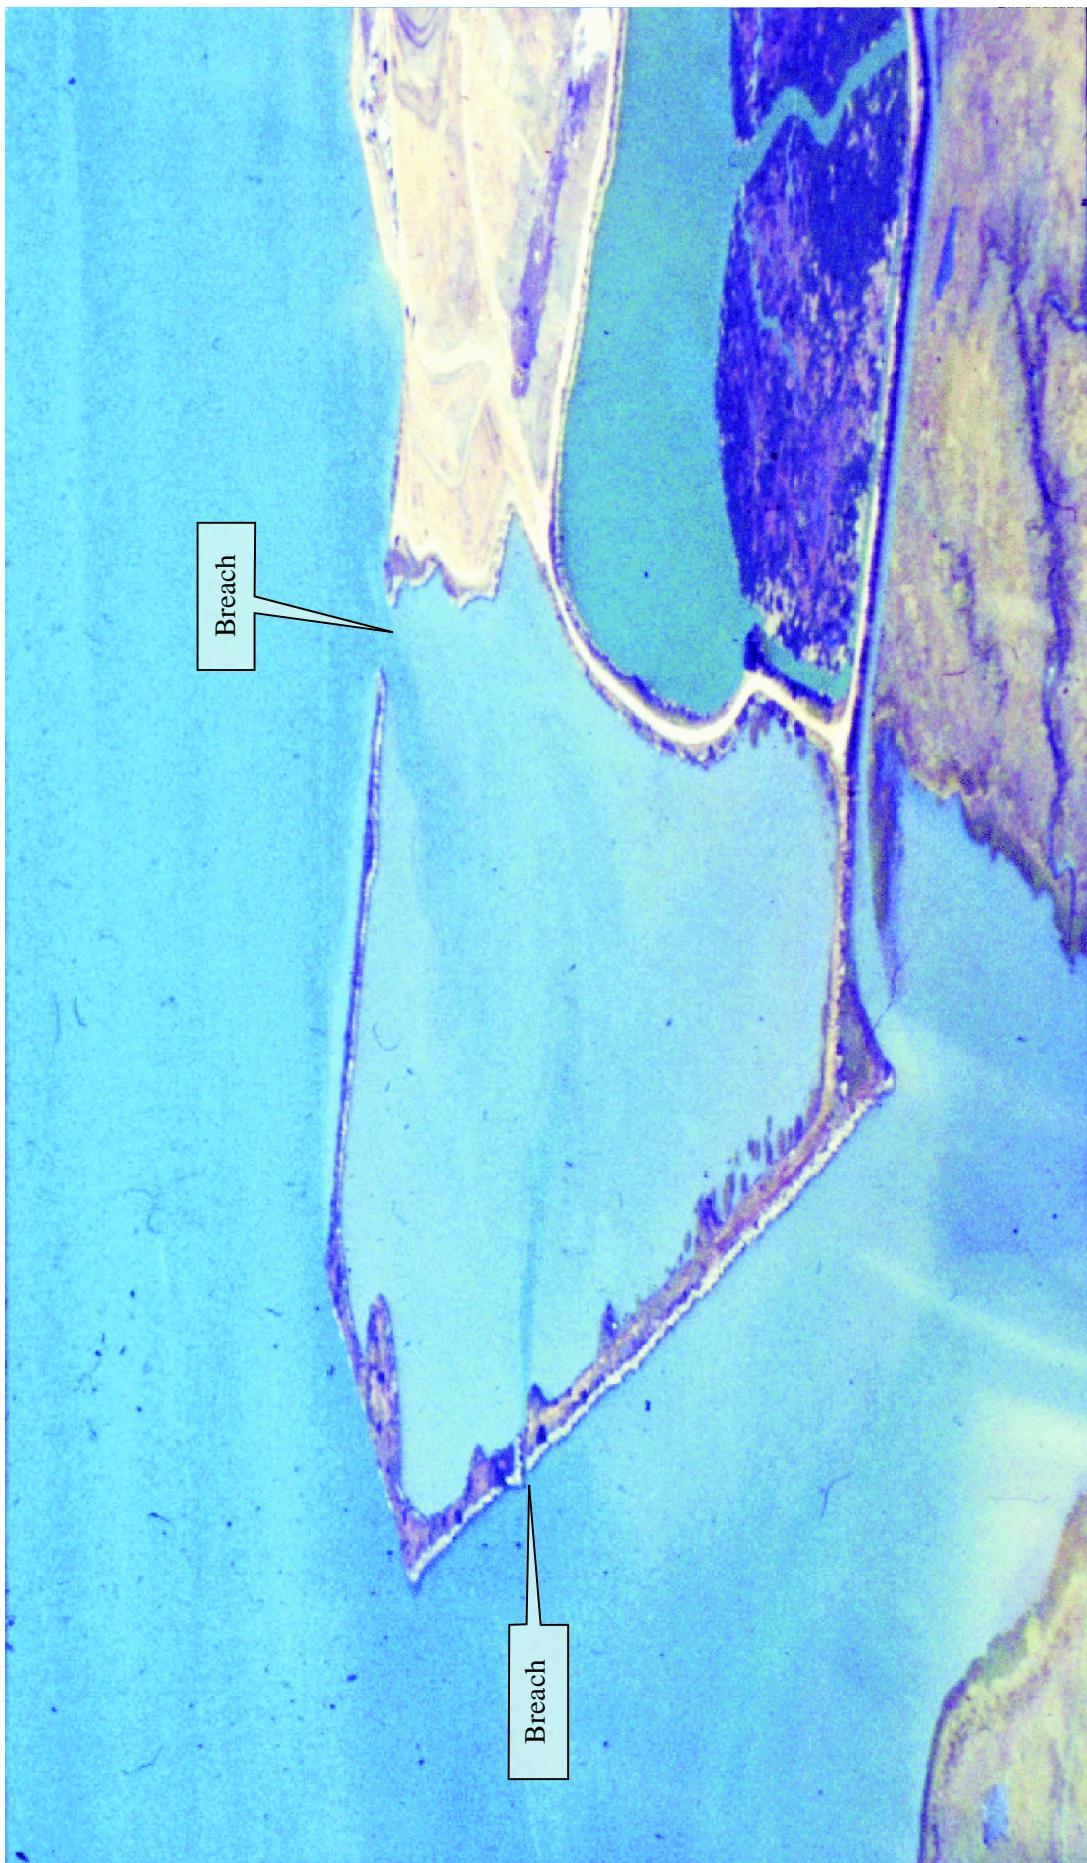
figure 36

1995, approximately 15 years after breaching.

As of 2004, the site has not changed significantly since it was breached between 1978 and 1981. Vegetation has not colonized the site, apparently due to the inhibition of sediment deposition by wind-waves.

**Nevada Shaped Parcel,
Richmond Shoreline at Wildcat Creek**

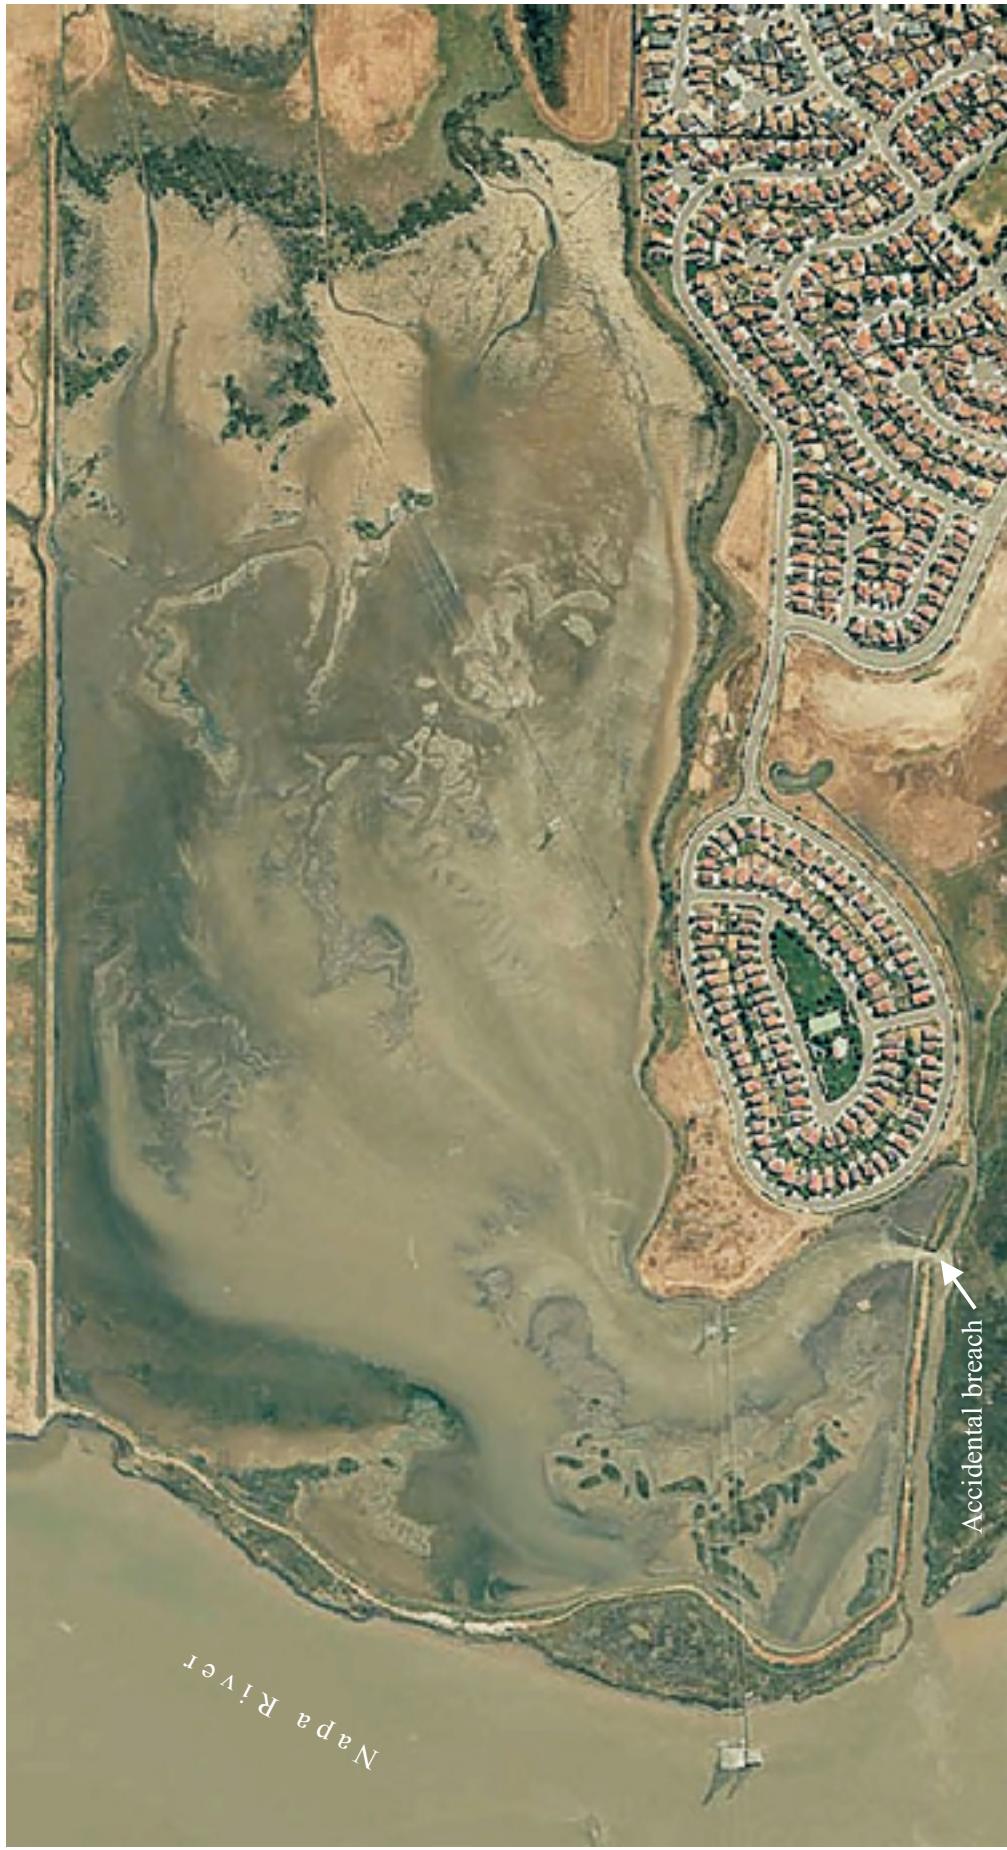
figure 37

Thirteen years after breaching, site remains mainly intertidal mudflat.

Slaughterhouse Point, Napa River

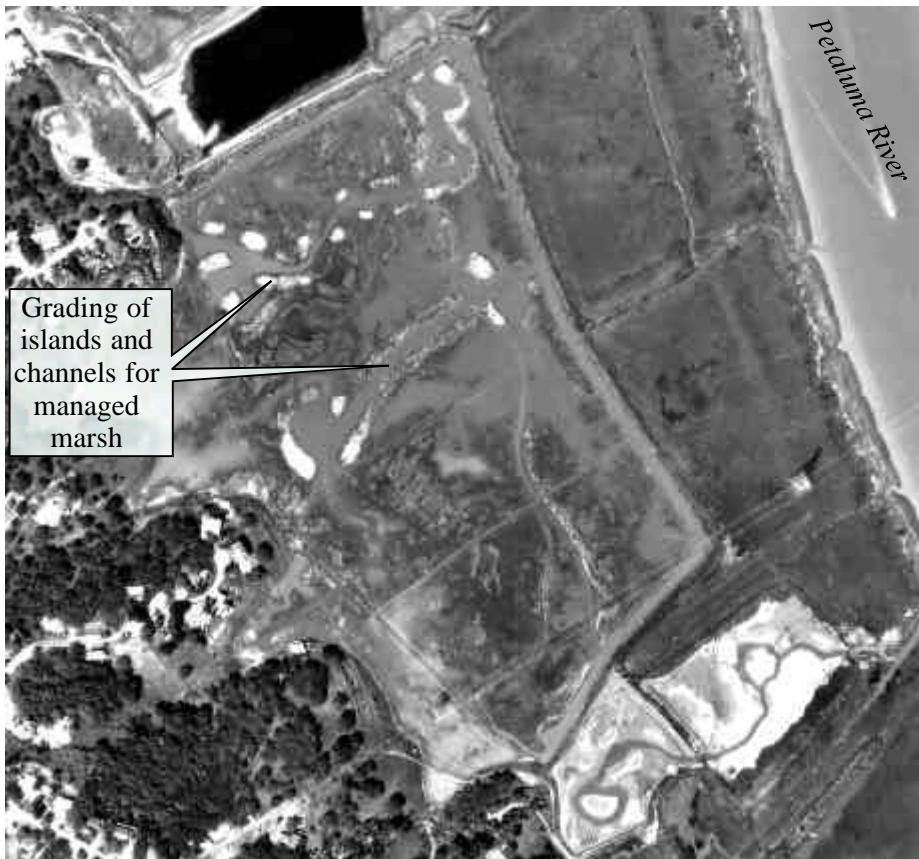
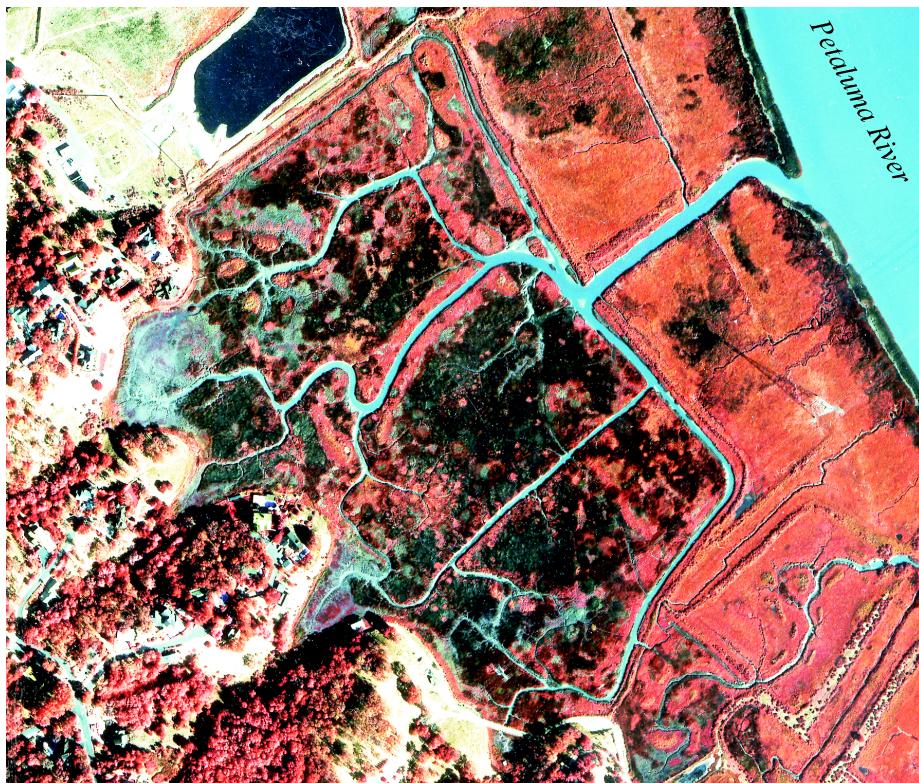
figure 47

Three months after accidental breaching of managed marsh - site is mainly subtidal due to constricted channel.

Predominantly *Scirpus maritimus* colonized marshplain. Channel has eroded to allow full tidal action.

Tidal Wetland Restoration Handbook
Green Point Marsh, Petaluma River

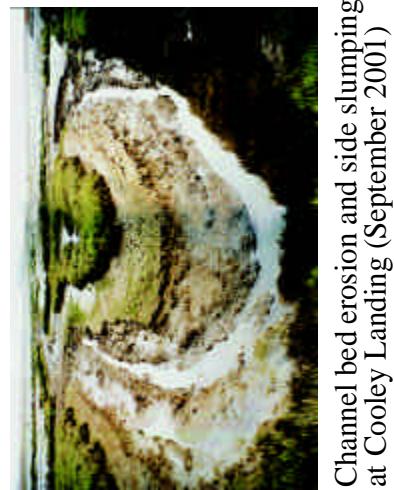
Channel bed erosion and side slumping
at Cooley Landing (September 2001)

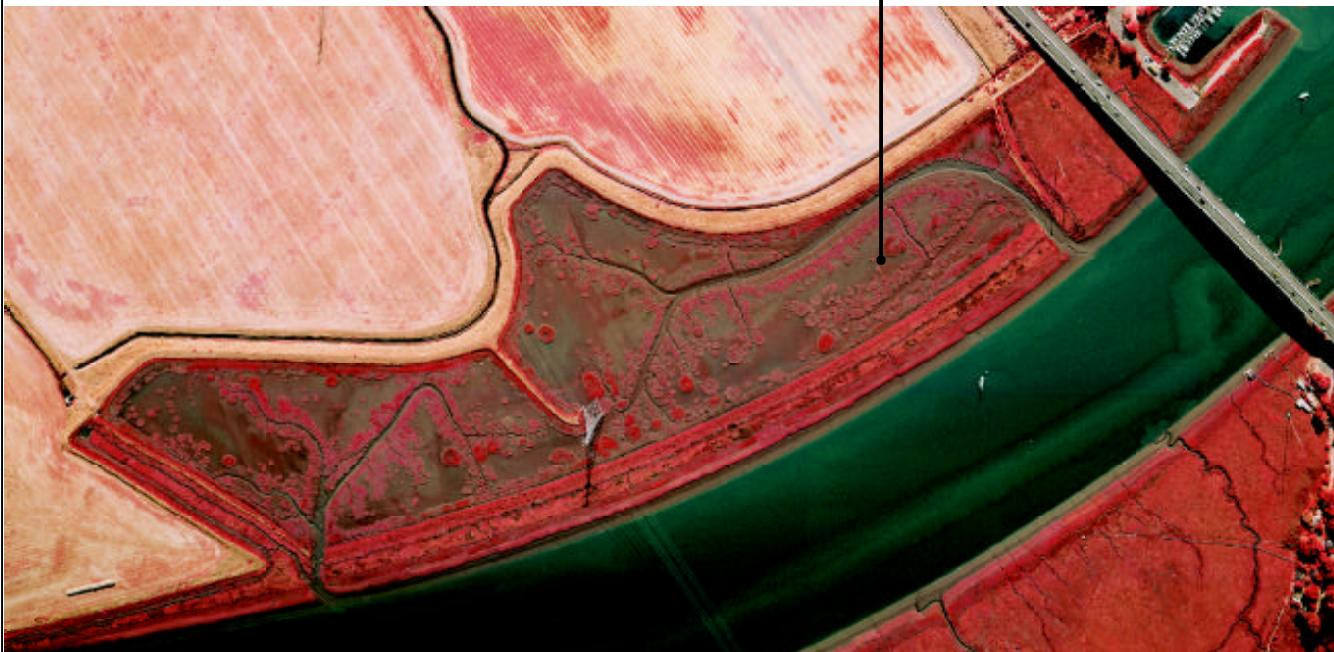
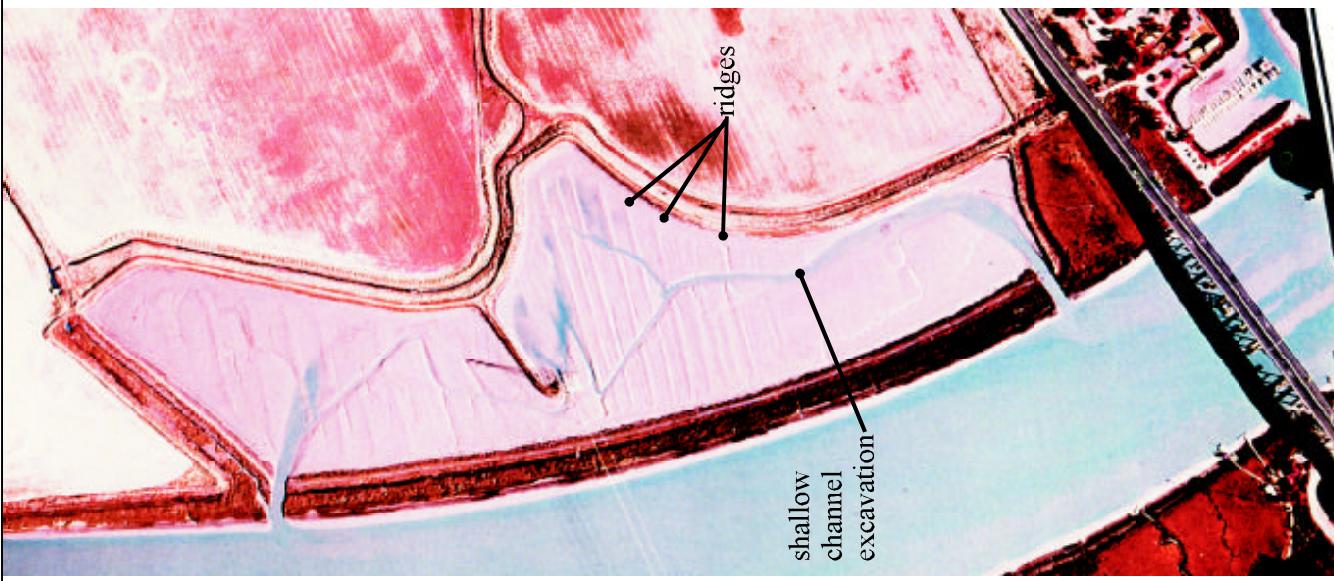
figure 50

- a) Abandoned saltpond showing design of
ditch blocks and breaches, prior to 2000
b) 9/22/03, 3 years after breaching

Tidal Wetland Restoration Handbook
Carl's Marsh
Petaluma River
PWA

*Spartina foliosa, *Scirpus maritimus*, & pickleweed have colonized. The imprint of the original grading is still evident.*

ridges
shallow channel excavation

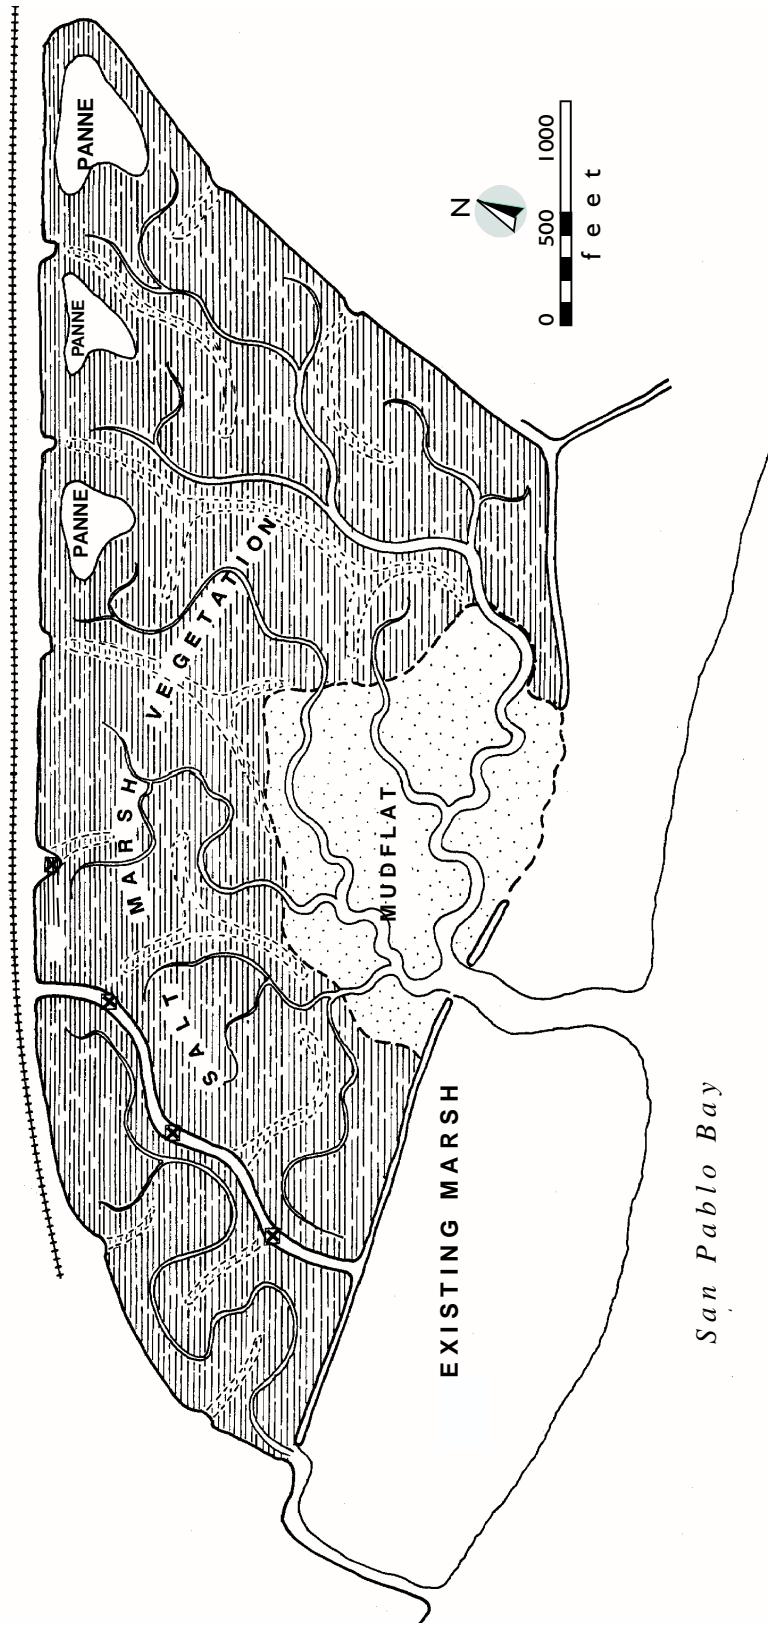
figure 52

Expected Evolution of Sonoma Baylands
(After approximately 10 years of
evolution as specified in design plan)
